Phillip Island Nature Parks' Coastal Process Study

November 2014

Project Name	Coastal Process Study
Client	Phillip Island Nature Park
Client Project Manager	Jarvis Weston
Water Technology Project Manager	Christine Lauchlan Arrowsmith
Report Authors	Christine Lauchlan Arrowsmith, Neville Rosengren, Josh Mawer, Alison Oates, Doug Frod
Job Number	3330-01
Report Number	R02
Document Name	3330-01R02v01a_PhillipiIsland_CHVA_Summary

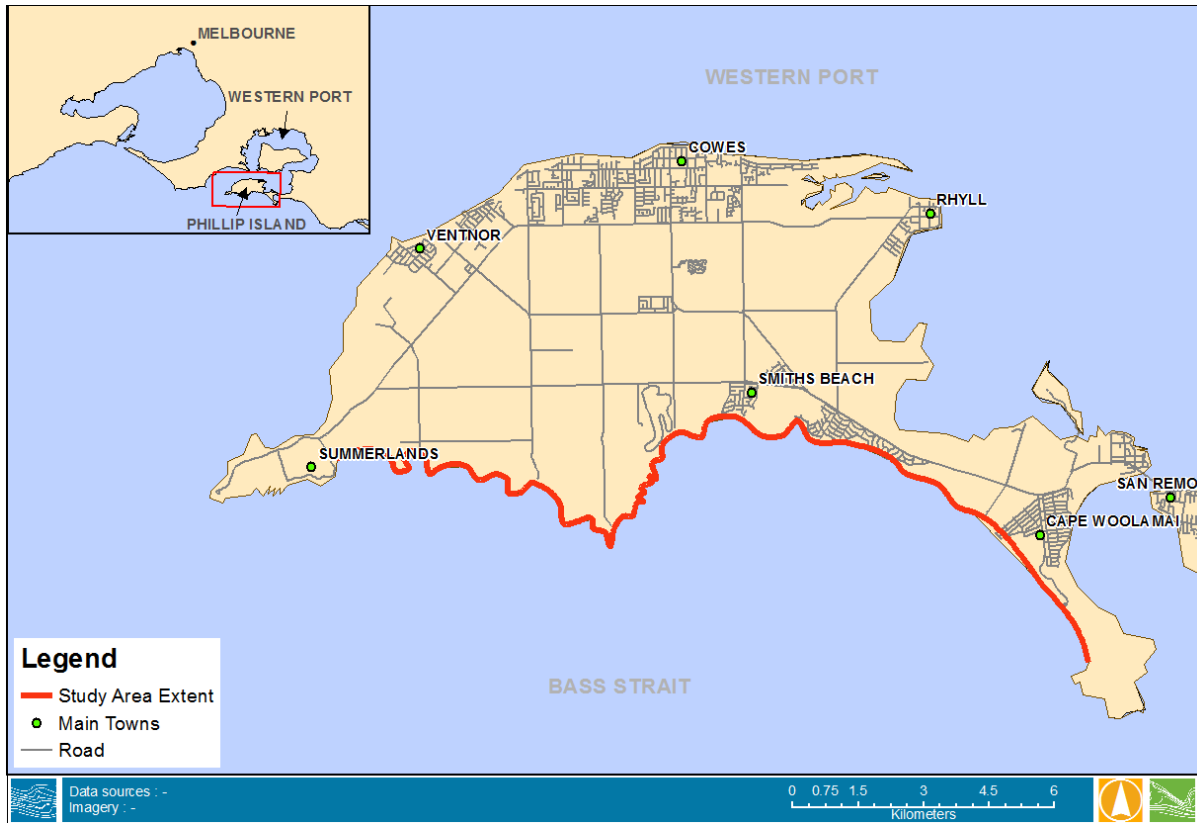
Figure 1-1 Phillip Island Coastal Process Study Area Overview

The boundaries of the study area for the Phillip Island Nature Parks' Coastal Processes Study were defined as extending from Penguin Parade, Summerland Bay in the west, to Magic Lands, Cape Woolamai in the East, as displayed in Figure 1-1.

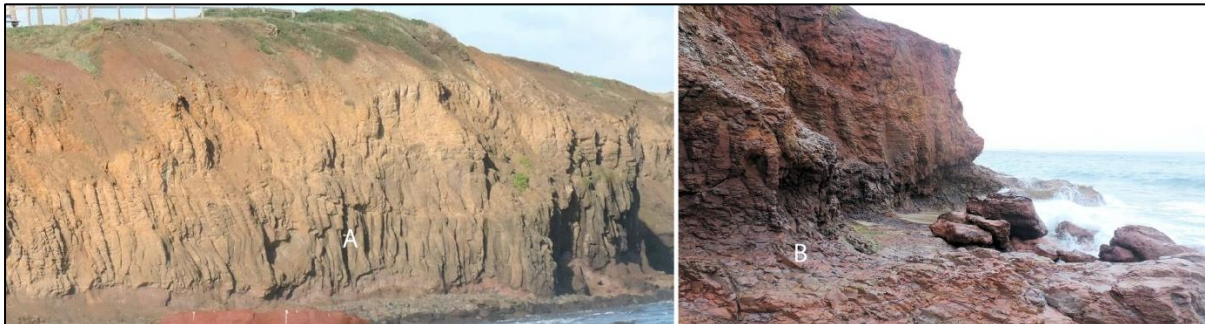
Figure 2-1 Vertical jointing in coherent basalt at Sunderland Bay (A) and close-spaced irregular jointing in fine-grained fragmental lava at Smith Beach (B)

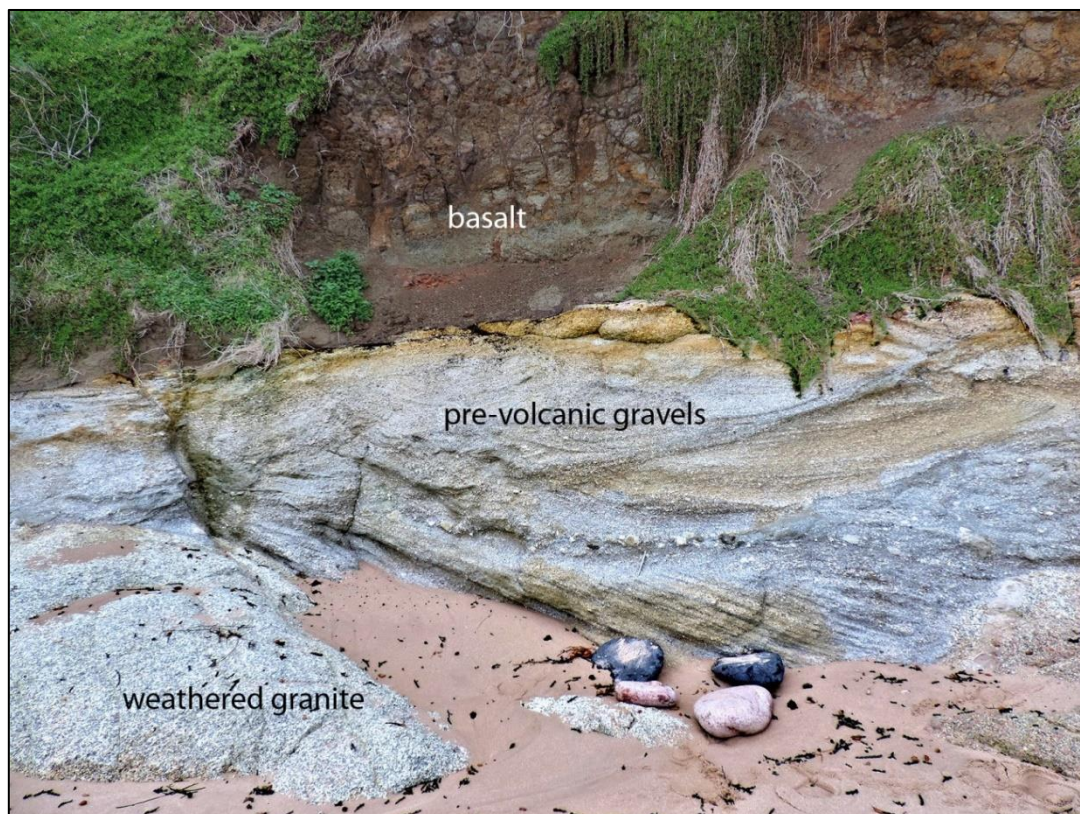
Figure 2-2 Weathered granite, sediments and basalt at the eastern end of Woolamai Beach

The main body of rock across Phillip Island is a substantial thickness of multiple flows of basalt lava, predominantly the Flinders Basalt, and other altered and fragmental lavas, Figure 2-1. These basaltic layers overlie weathered granite at Pyramid Rock and Cape Woolamai, Figure 2-2.

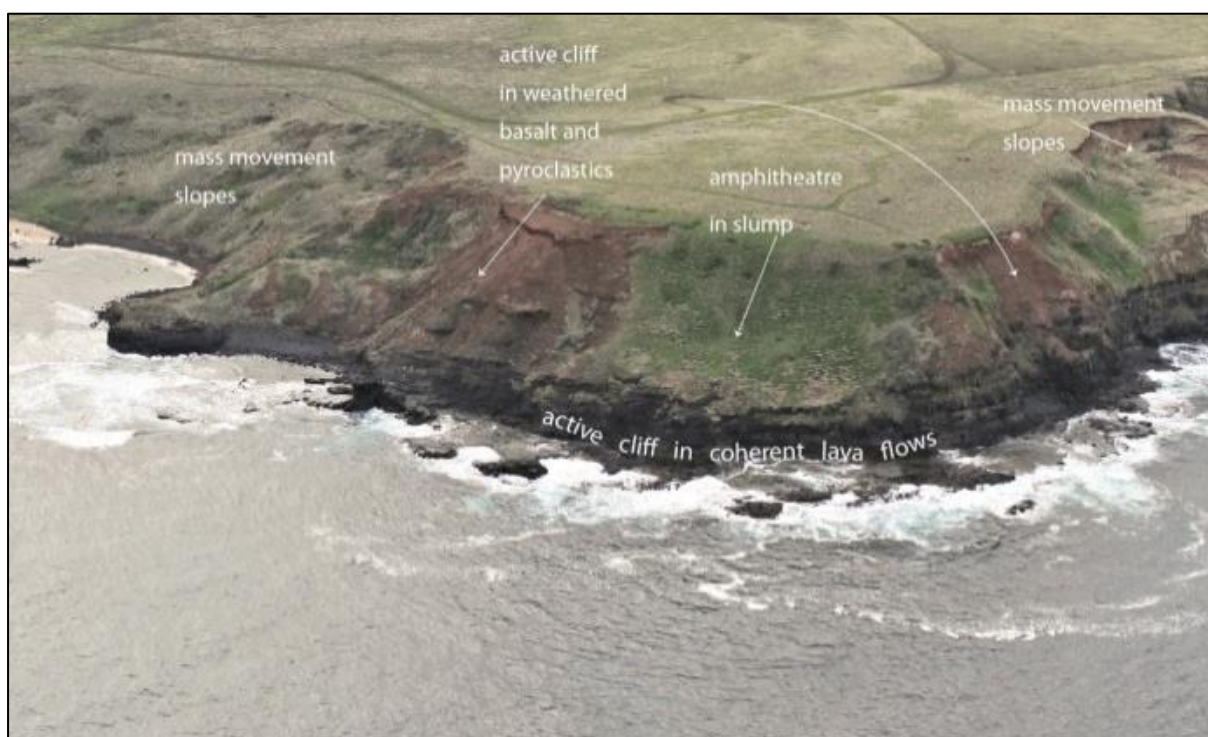
Figure 2-4 Examples of Steep Coast Landformd (photo: Neville Rosengren)

Five classes of steep coasts are recognised on the south coast of Phillip Island: Active Cliffs, Active Mass-movement Slopes, Bluffs, Amphitheatres, and Plunging Cliffs as shown in Figure 2-4 and summarised in Table 2-1. Active cliffs and active mass movement slopes represent the steep coast landforms most susceptible to instability and erosion as a result of coastal processes. Coastal bluffs and amphitheatres are landforms now generally isolated from direct marine action and not currently subject to active erosion, while plunging cliffs (which occur at Cape Woolamai) are not generally active within the timescales considered by this project.

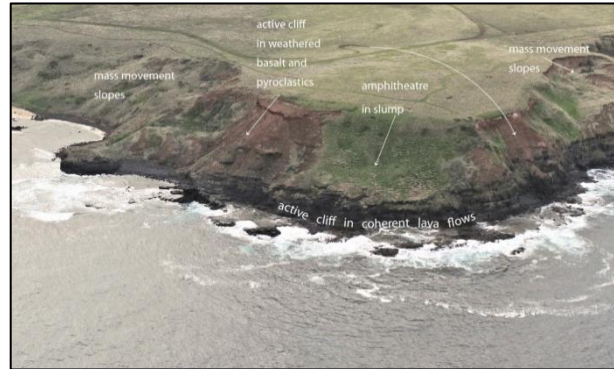
A. Active cliffs in coherent basalt

The cliff form is controlled by fractures in the basalt, so slope angles can be near vertical. Discrete blocks are loosened and dislodged by wave action.

Complex 50 metre high slopes at Red Bluff

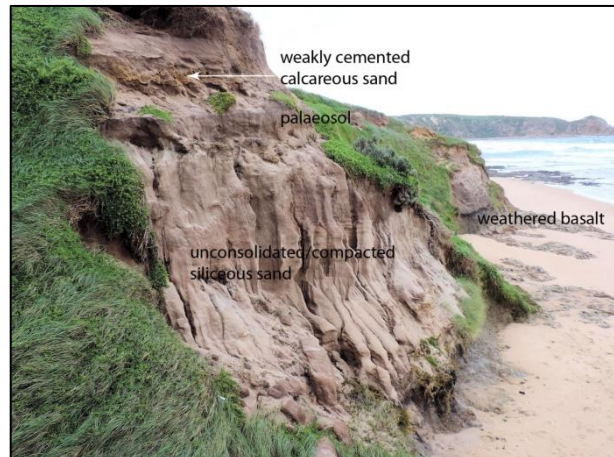
C. Active cliffs in sand

Active cliffs in unconsolidated and poorly consolidated sand bodies occur intermittently backing Woolamai Beach. Cliffs in sands are partly activated by runoff and groundwater seepage forming rills and washing sand and clay to the base where they form short-lived alluvial and colluvial fans. As high tide storm waves reach the cliff base, these deposits are frequently dispersed, exposing the cliff to direct wave action.

Active cliff in weakly consolidated & unconsolidated sand, Magic Lands

Figure 2-5 Overview of Active Cliff Types on Phillip Island (Photos: N. Rosengren, June 2014)

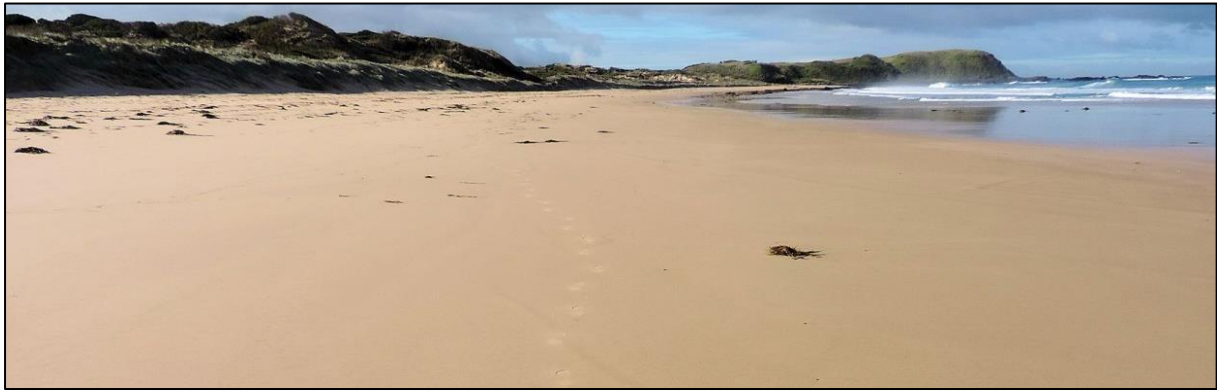
Figure 2-6 Summerland Beach profile (N. Rosengren 4 June 2014)

Long sand beaches occur in coastal embayments with long projecting headlands at Summerland Beach (Figure 2-6), Kitty Miller Bay, Hutchison Beach, Berrys Beach and Smiths Beach and in several pocket beaches east of Pyramid Rock e.g. Jessie Island. East of Sunderland Bay to Magic Lands, are two long sectors of almost continuous beach backed by cliffed slopes and divided by the low headland at Forrest Caves.

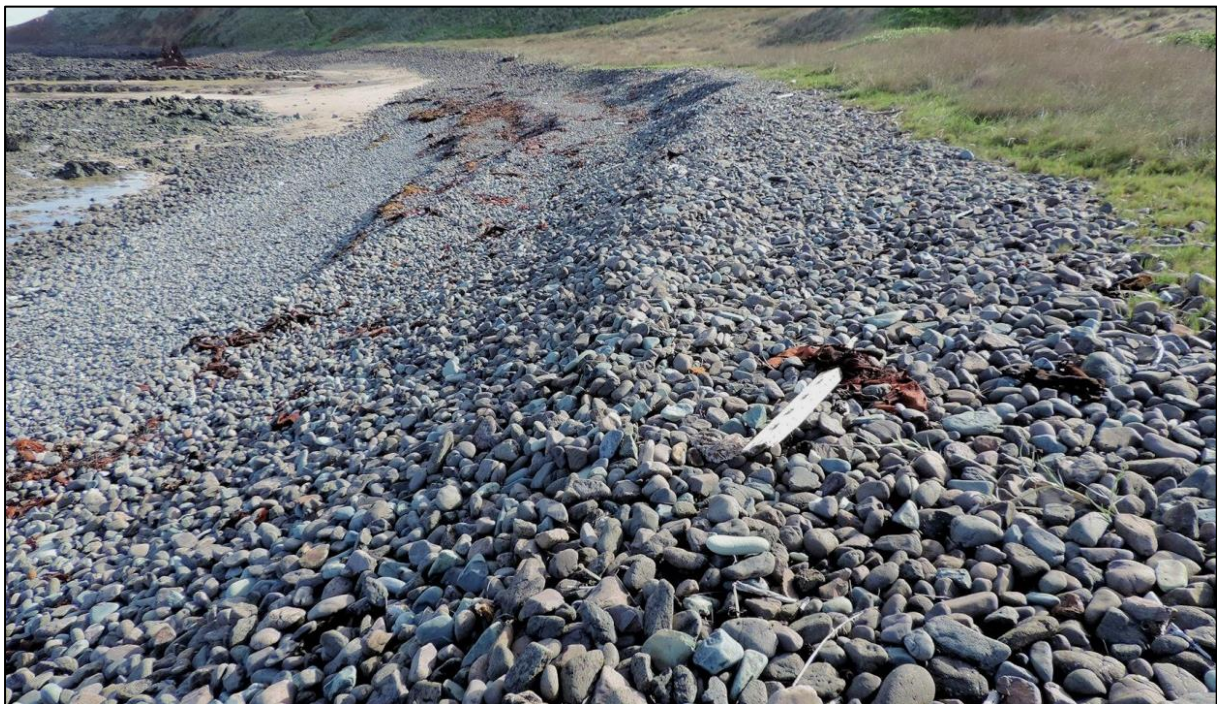
Figure 2-7 Steep gravel beach with multiple storm scarps and berms, Watt Point (N. Rosengren 4 June 2014)

Gravel beaches are widespread and in places include abundant cobbles and fine to medium boulders, Figure 2-7. They are steep, reflective beaches with storm scarps, ridges and berms preserved for months.

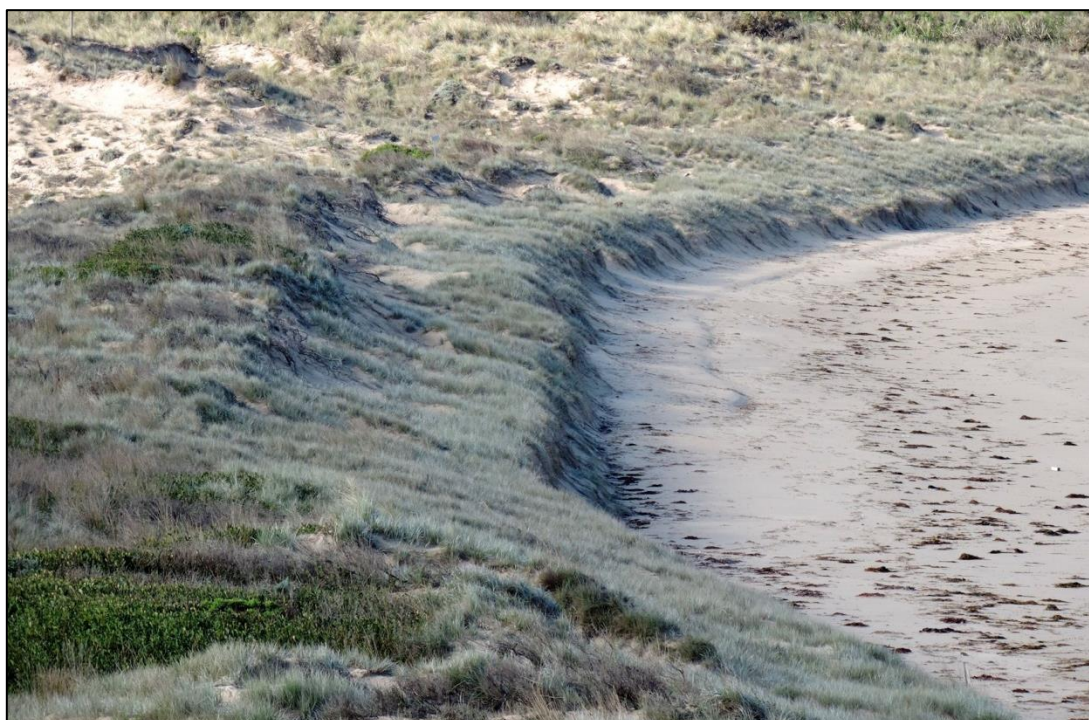
Figure 2-8 Incipient, established foredunes and transgressive dunes, Summerland (N. Rosengren 6 June 2014)

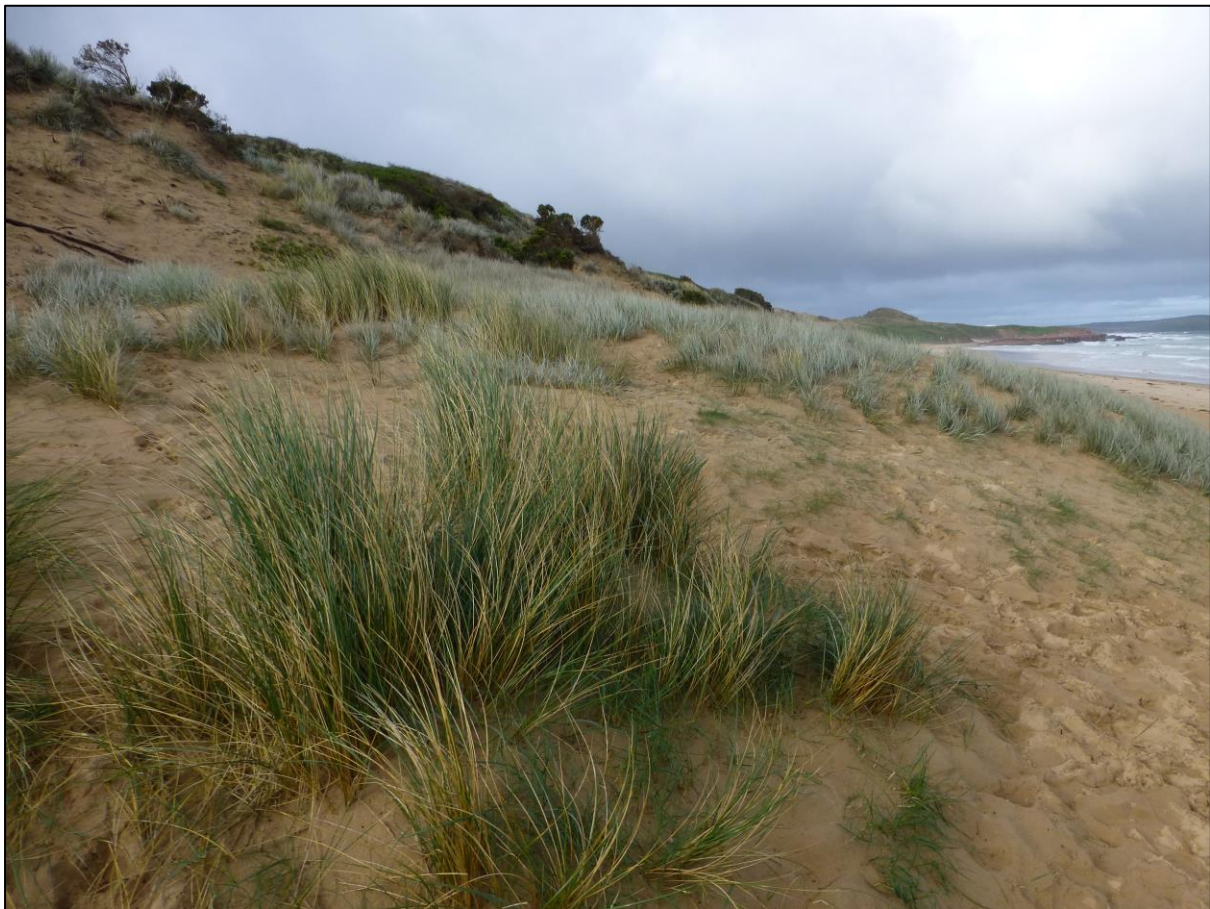
Figure 2-9 Marram Grass (central foreground), Sea Wheat-grass (right foreground), and Hairy Spinifex (rear) growing on incipient dunes at Forrest Caves (Photo by Doug Frood, June 2014)

Both species (Marram Grass and Sea Wheat-grass) along with the native dune grass, Hairy Spinifex, as shown in Figure 2-9.

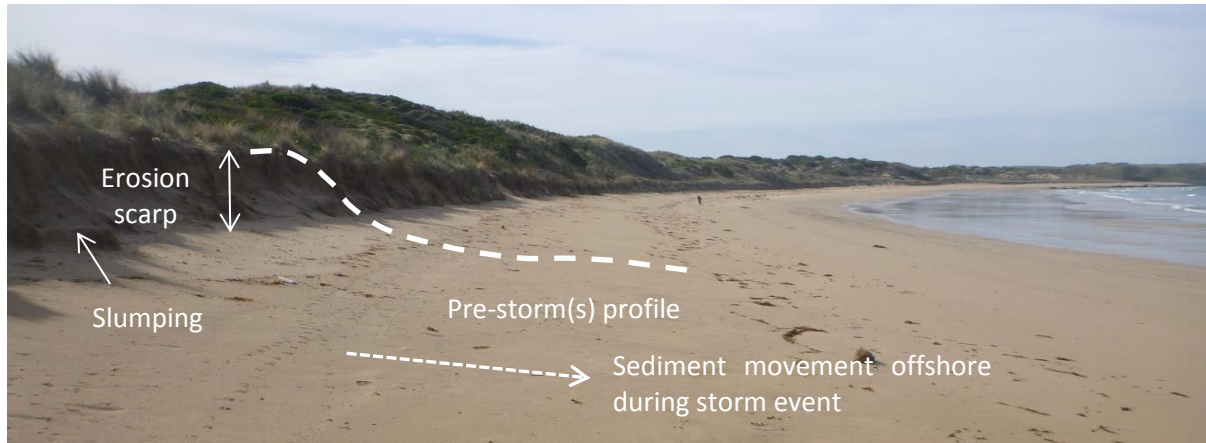
Figure 3-3 Generalised Beach-Dune Processes (photo 4 June 2014)

As well as long term change, short term changes to the beach-dune profile occur as a response to storm events, specifically the formation of erosion scarps (Figure 3-3). The current form of the erosion scarps may be steeper than in the past due to the presence of introduced dune vegetation species. An example of an erosion scarp and the recent response to a storm event is shown in Figure 3-4.

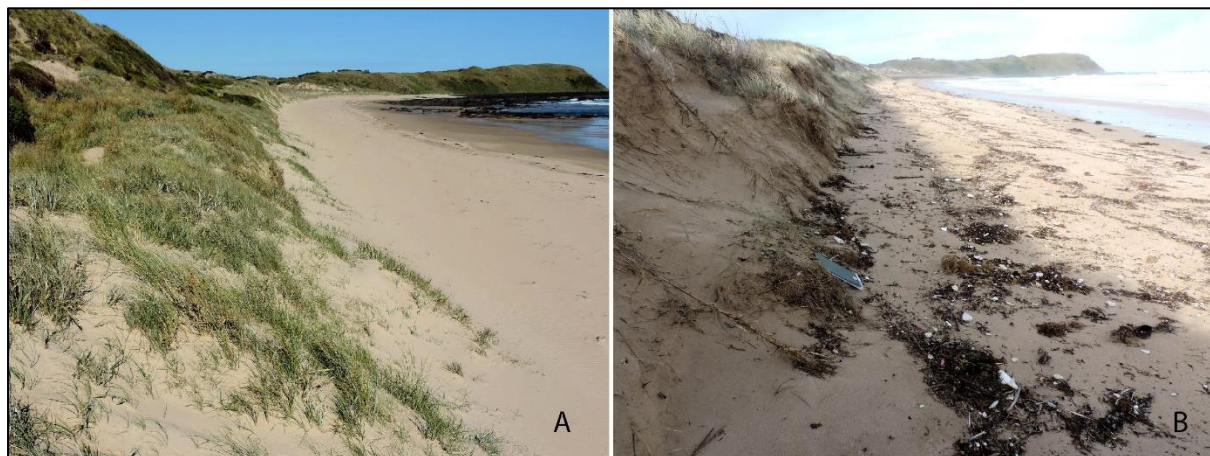
Figure 3-4 Dune-foot scarp at the far eastern end of Summerland Bay: (A) 17 Nov 2013, (B) 18 July 2014 (photos: N Rosengren)

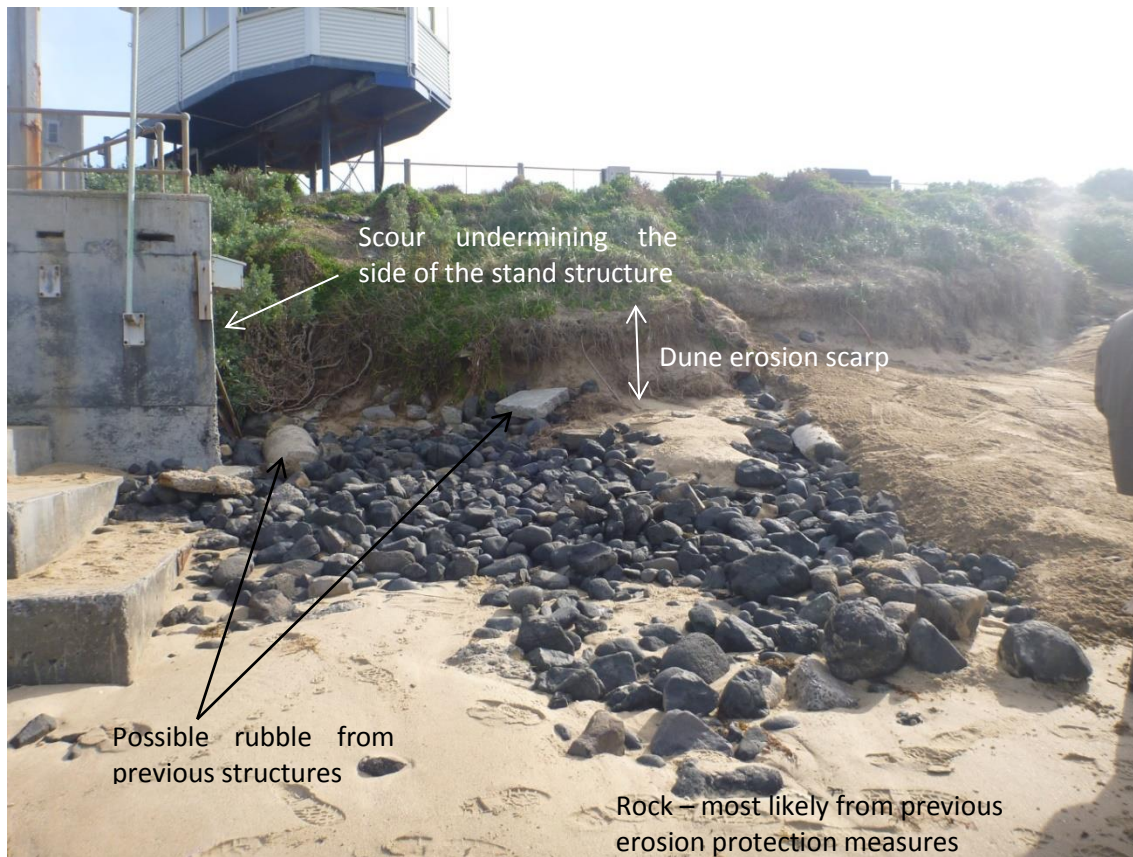
Figure 3-5 Erosion exposing and undermining sections of the concrete stands

Erosion of sand from in front of and adjacent to the Penguin Parade viewing stands has also been an issue since their construction. Figure 3-5 shows an example of the current active erosion at the interface between the stands and the adjacent dunes. Recession of the dunes has occurred at the eastern end of the east stand in particular.

The current localised erosion of the dunes adjacent to the viewing stands is being exacerbated by the exposure of the lower steps of the stands during storm events.

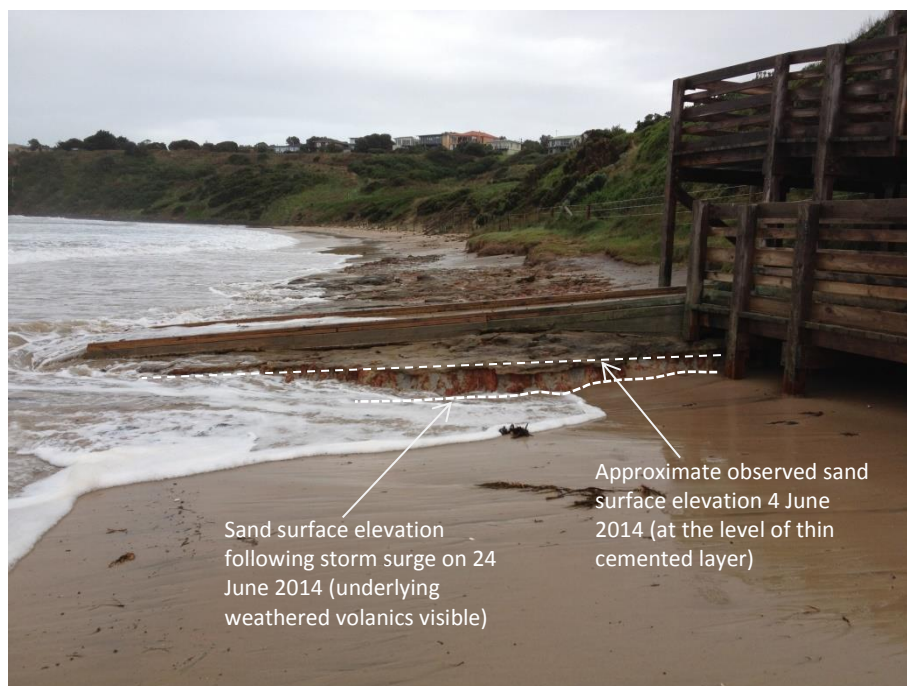
Figure 3-6 Interface between the beach and backshore in June 2014, following a storm surge event

Due to the lack of backshore dunes and the presence of the steep slope at the back of the beach, the dominant response to storm events is a flattening of the beach profile and increased exposure of the toe of the slope.

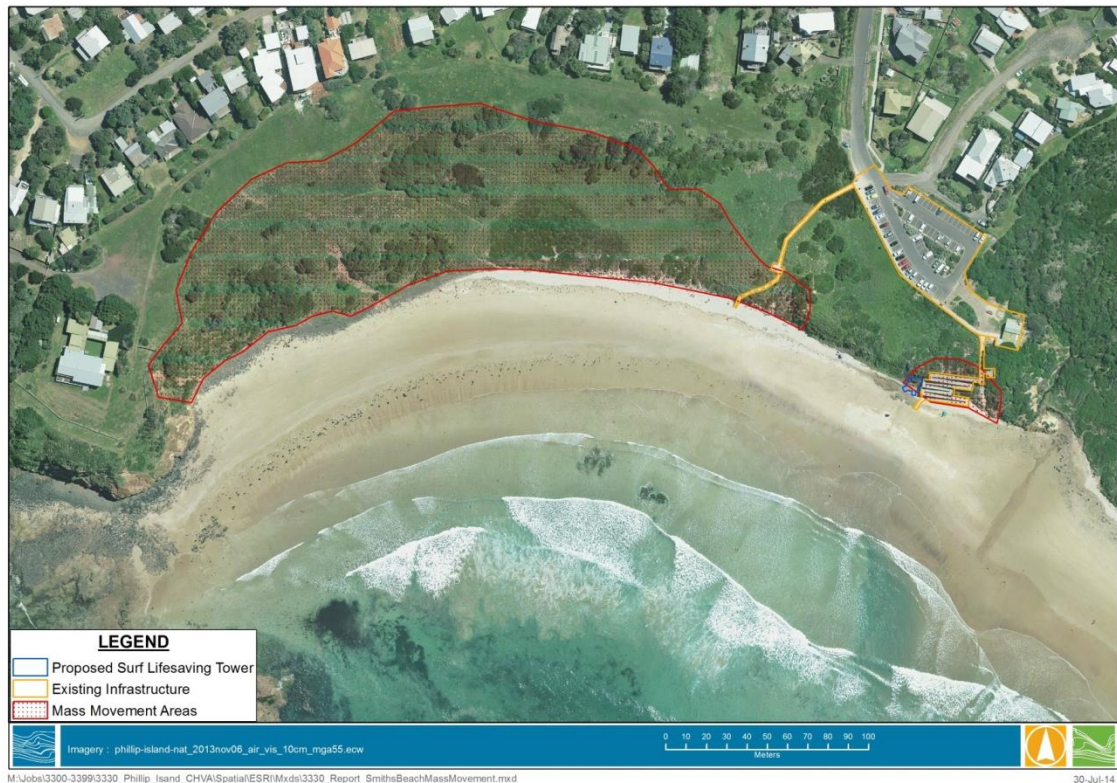
Figure 3-7 Location of Mass Movement Slopes at Smiths Beach

The steep slope at the back of the beach is defined as a mass movement slope and although the analysis of recent slope profiles did not identify any significant changes over the period 2009-2014 there is an existing and future risk of slope failure of these areas. These areas have been identified using the available terrain data and are shown in Figure 3-7.

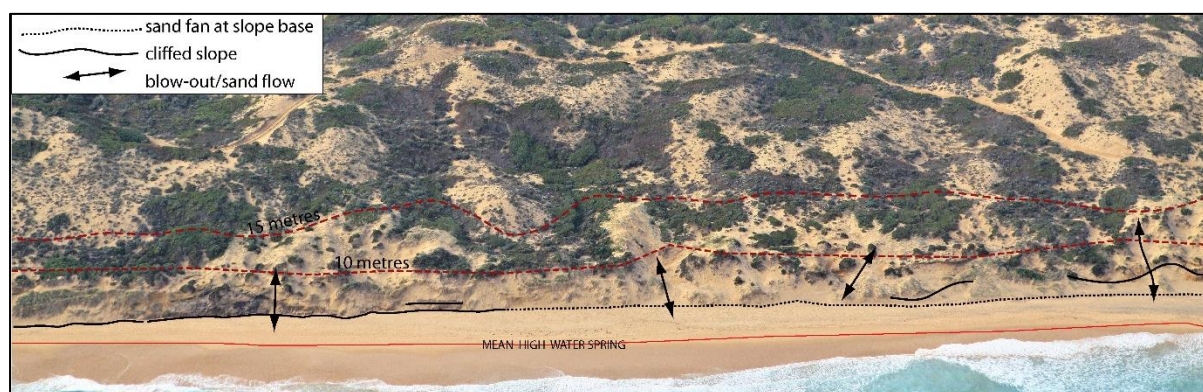
Figure 3-8 Detail of steep slope backing Woolamai Beach north of Magic Lands (N. Rosengren 2 June 2014)

The form of the steeply rising slope at the back of the beach changes in both time and space. At times it is an active cliff or mass-movement slope and the exposed grey sand and overlying organic and calcareous beds are washed by high tide storm waves. At times part of the cliff is covered by a steeply sloping sand apron, either wave-deposited or wind-blown, Figure 3-8.
